**HERITAGE PALMS  
COMMUNITY DEVELOPMENT DISTRICT**

FEBRUARY 24, 2020  
BOARD OF SUPERVISORS MEETING  
AGENDA PACKET

Community Field Services personnel conducted a visual inspection of all 169 sanitary sewer manhole covers along all roadways throughout the Heritage Palms community during the week of February 10<sup>th</sup>, 2020. Each manhole cover was measured to determine its depth from the surface of the roadway asphalt. The sanitary sewer manhole covers are labeled as A1 thru A19, B1 thru B31, C1 thru C23, D1 thru D32 and MH1 thru MH59 and their locations can be found on the attached Sanitary Manhole Exhibit created by Banks Engineering.

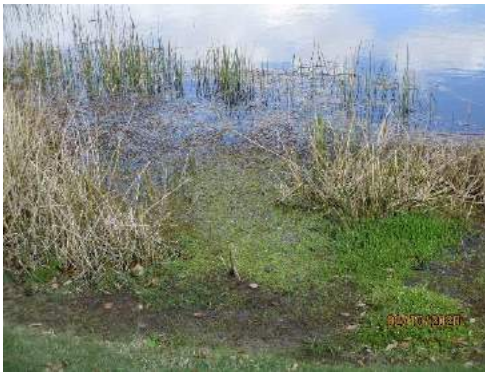
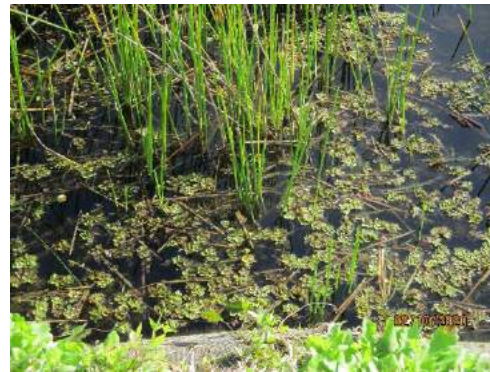
- i. Torpedo Grass in Lakes: 10, 12, 13, 28, 30, L-11 & Canal C-7. Very low to Low presence.
- ii. Alligator weed in Lakes: L-5. Low presence.
- iii. Spatterdock in Lakes: L-1. Low presence.
- iv. Salvinia in Lakes: 6, 7, 10, 19, 29 & L-12. Low presence. Lake 4. Medium presence.

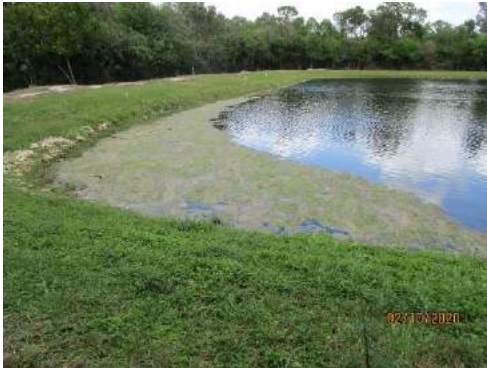
**Lake 31**

- i. Planktonic algae: None observed.
- ii. Filamentous algae:
  1. Low density in Lakes: 5, 9, 10, 11, 13, 17, 20, 21, L-3, L-9 & Canals C-7.
  2. Medium density in Lakes: 15 & 31.
  3. High density in Lakes: None.

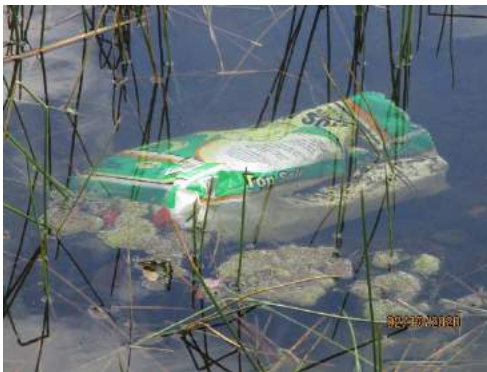
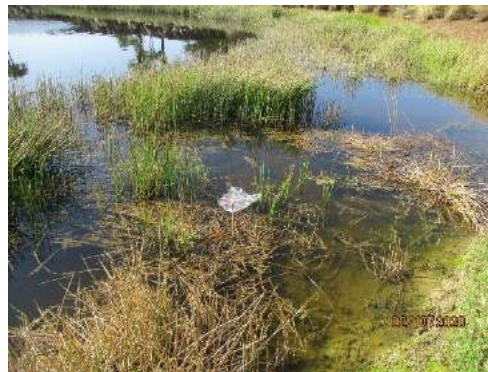
- g. Fish:** No nuisance fish were observed this month.
- h. Trash:** Trash was observed floating in multiple lakes this month. Hot spots included Lakes: 1, 6, 7, 9, 14, 19, 20, 30, 31, 33, L-1 & L-11. We recommend having a trash clean-up completed.

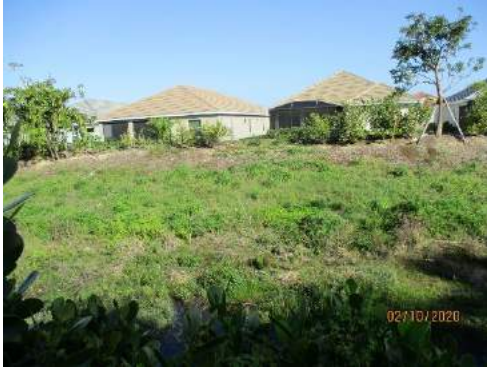
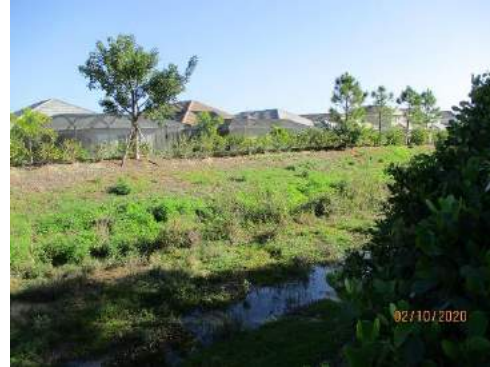
- i. The north berm along Lake 30 is due for its annual cutting.

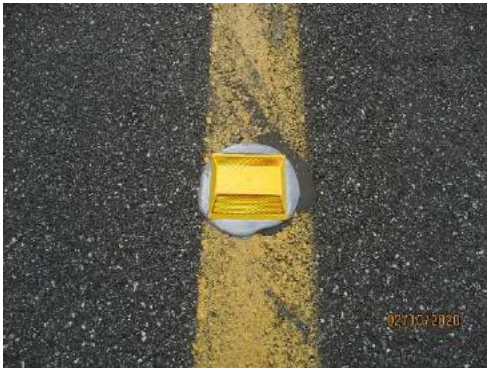
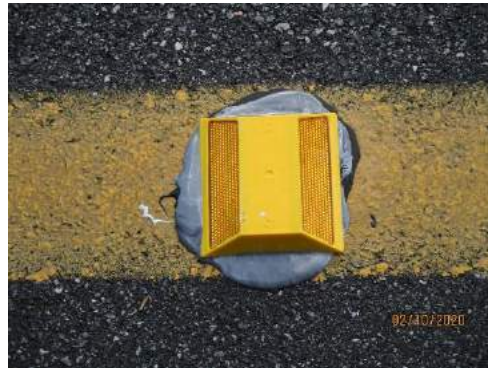
- a. **Asphalt:** No concerns observed this month.
- b. **Signage / Landscaping:**
  - i. Maintenance staff replaced the 12 missing amber roadway reflectors this week. 5 on Gator Palm, 5 on Washingtonia Palm and 2 on Queen Palm.

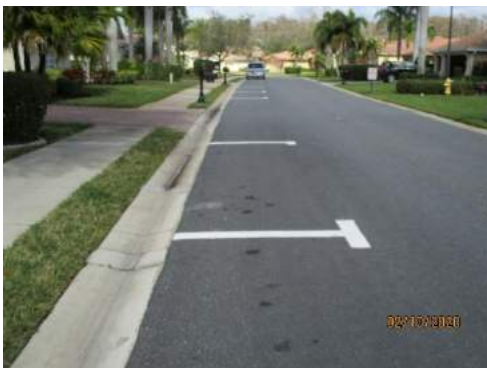
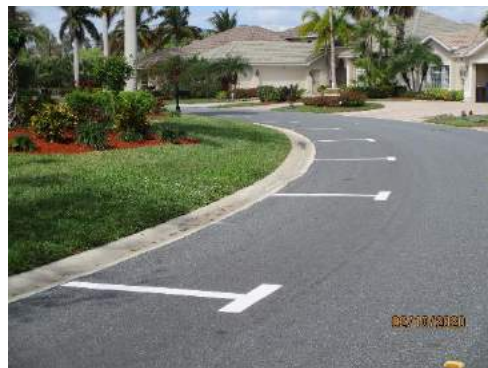
- ii. New parking spaces were observed painted along Seminole Palm Way. I am not aware if any communication was made to the CDD before the roadway was painted.

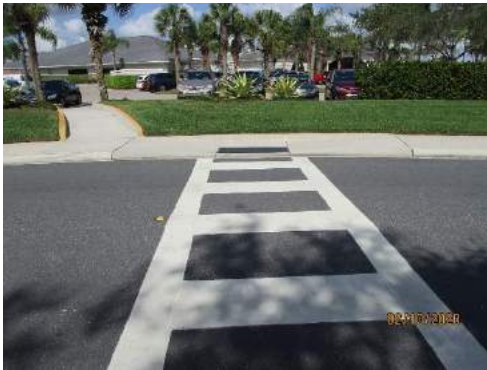
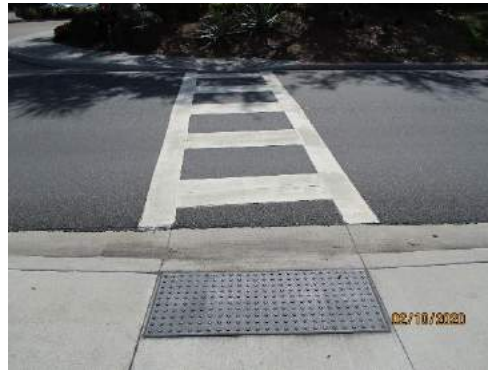
- c. **Pavers:** The CDD is currently in the process of having the pavers replaced & leveled along Heritage Palms Blvd., Curry Palm Lane, in front of the clubhouse on Washingtonia Palm Way and on King Palm Court.
  - d. **Curbing / Gutters:** No concerns observed this month.
4. **Sidewalks:** The General Manager, Gary Piotrowski informed us of a safety concern with the crosswalk in front of the clubhouse which leads over to the activity center. He informed us that when pedestrians are using the crosswalk, they tend to walk outside of the crosswalk stripes towards the yellow lines at the cut through to the clubhouse. Gary would like to have the ADA mat changed to a yellow one and to also paint the curbing yellow on both sides of the ADA mat to help direct pedestrians to the sidewalk ramp. The ADA mat is 2 feet wide by 5 feet long.

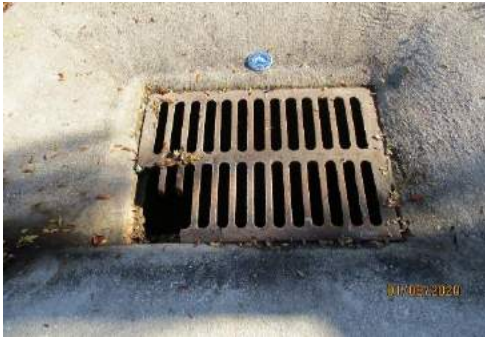
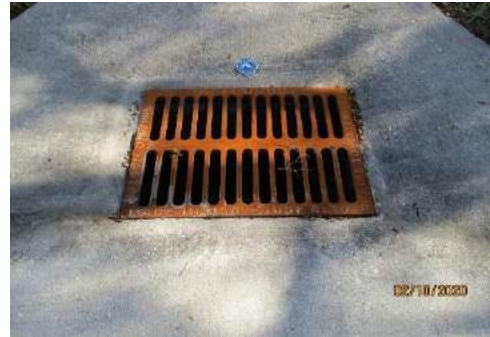
- i. The catch basin located at 10321 White Palm Way that was missing 2 slats from its grate has been replaced.

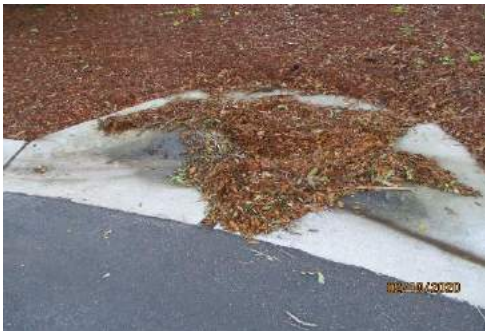
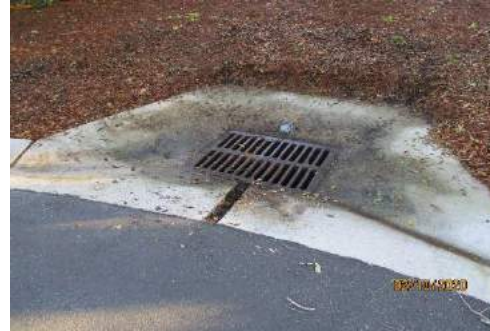
**Before & After**

- ii. The catch basin at the end of Curry Palm Lane was covered by Oak tree leaves. We went ahead and cleared off the structure.

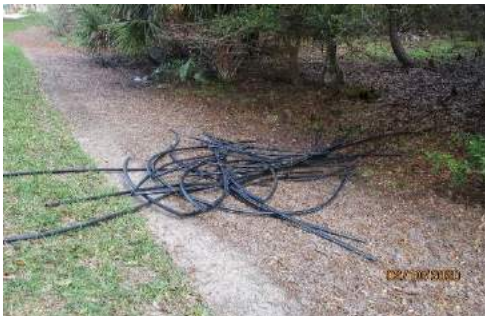
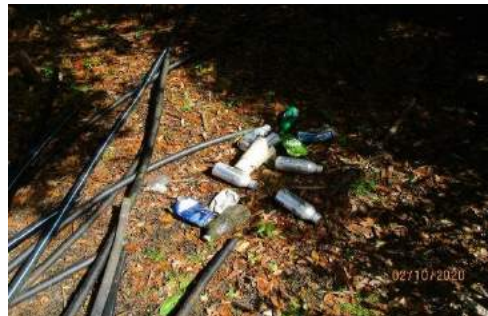
- a. 9/06/19: Cut back the willow trees and any other vegetation that is encroaching into the canals this winter. Work order 1360 pending March / April for lowest water levels.
- b. 10/09/19: Replace the rusting out grate between Lakes L-11 & L-12. 53"x35" Type D grate. Work order 1380. Grate has been replaced.
- c. 12/12/19: If the lines are no longer in use remove them from the preserve area at the intersection of Wine Palm Road and King Palm Court. Spoke with Greg K. and confirmed the lines are no longer active so we went ahead and removed them. We also removed multiple bottles and cans from this preserve as well.
