**HERITAGE PALMS  
COMMUNITY DEVELOPMENT DISTRICT**

FEBRUARY 24, 2020  
BOARD OF SUPERVISORS MEETING  
AGENDA PACKET

Community Field Services personnel conducted a visual inspection of all 169 sanitary sewer manhole covers along all roadways throughout the Heritage Palms community during the week of February 10<sup>th</sup>, 2020. Each manhole cover was measured to determine its depth from the surface of the roadway asphalt. The sanitary sewer manhole covers are labeled as A1 thru A19, B1 thru B31, C1 thru C23, D1 thru D32 and MH1 thru MH59 and their locations can be found on the attached Sanitary Manhole Exhibit created by Banks Engineering.

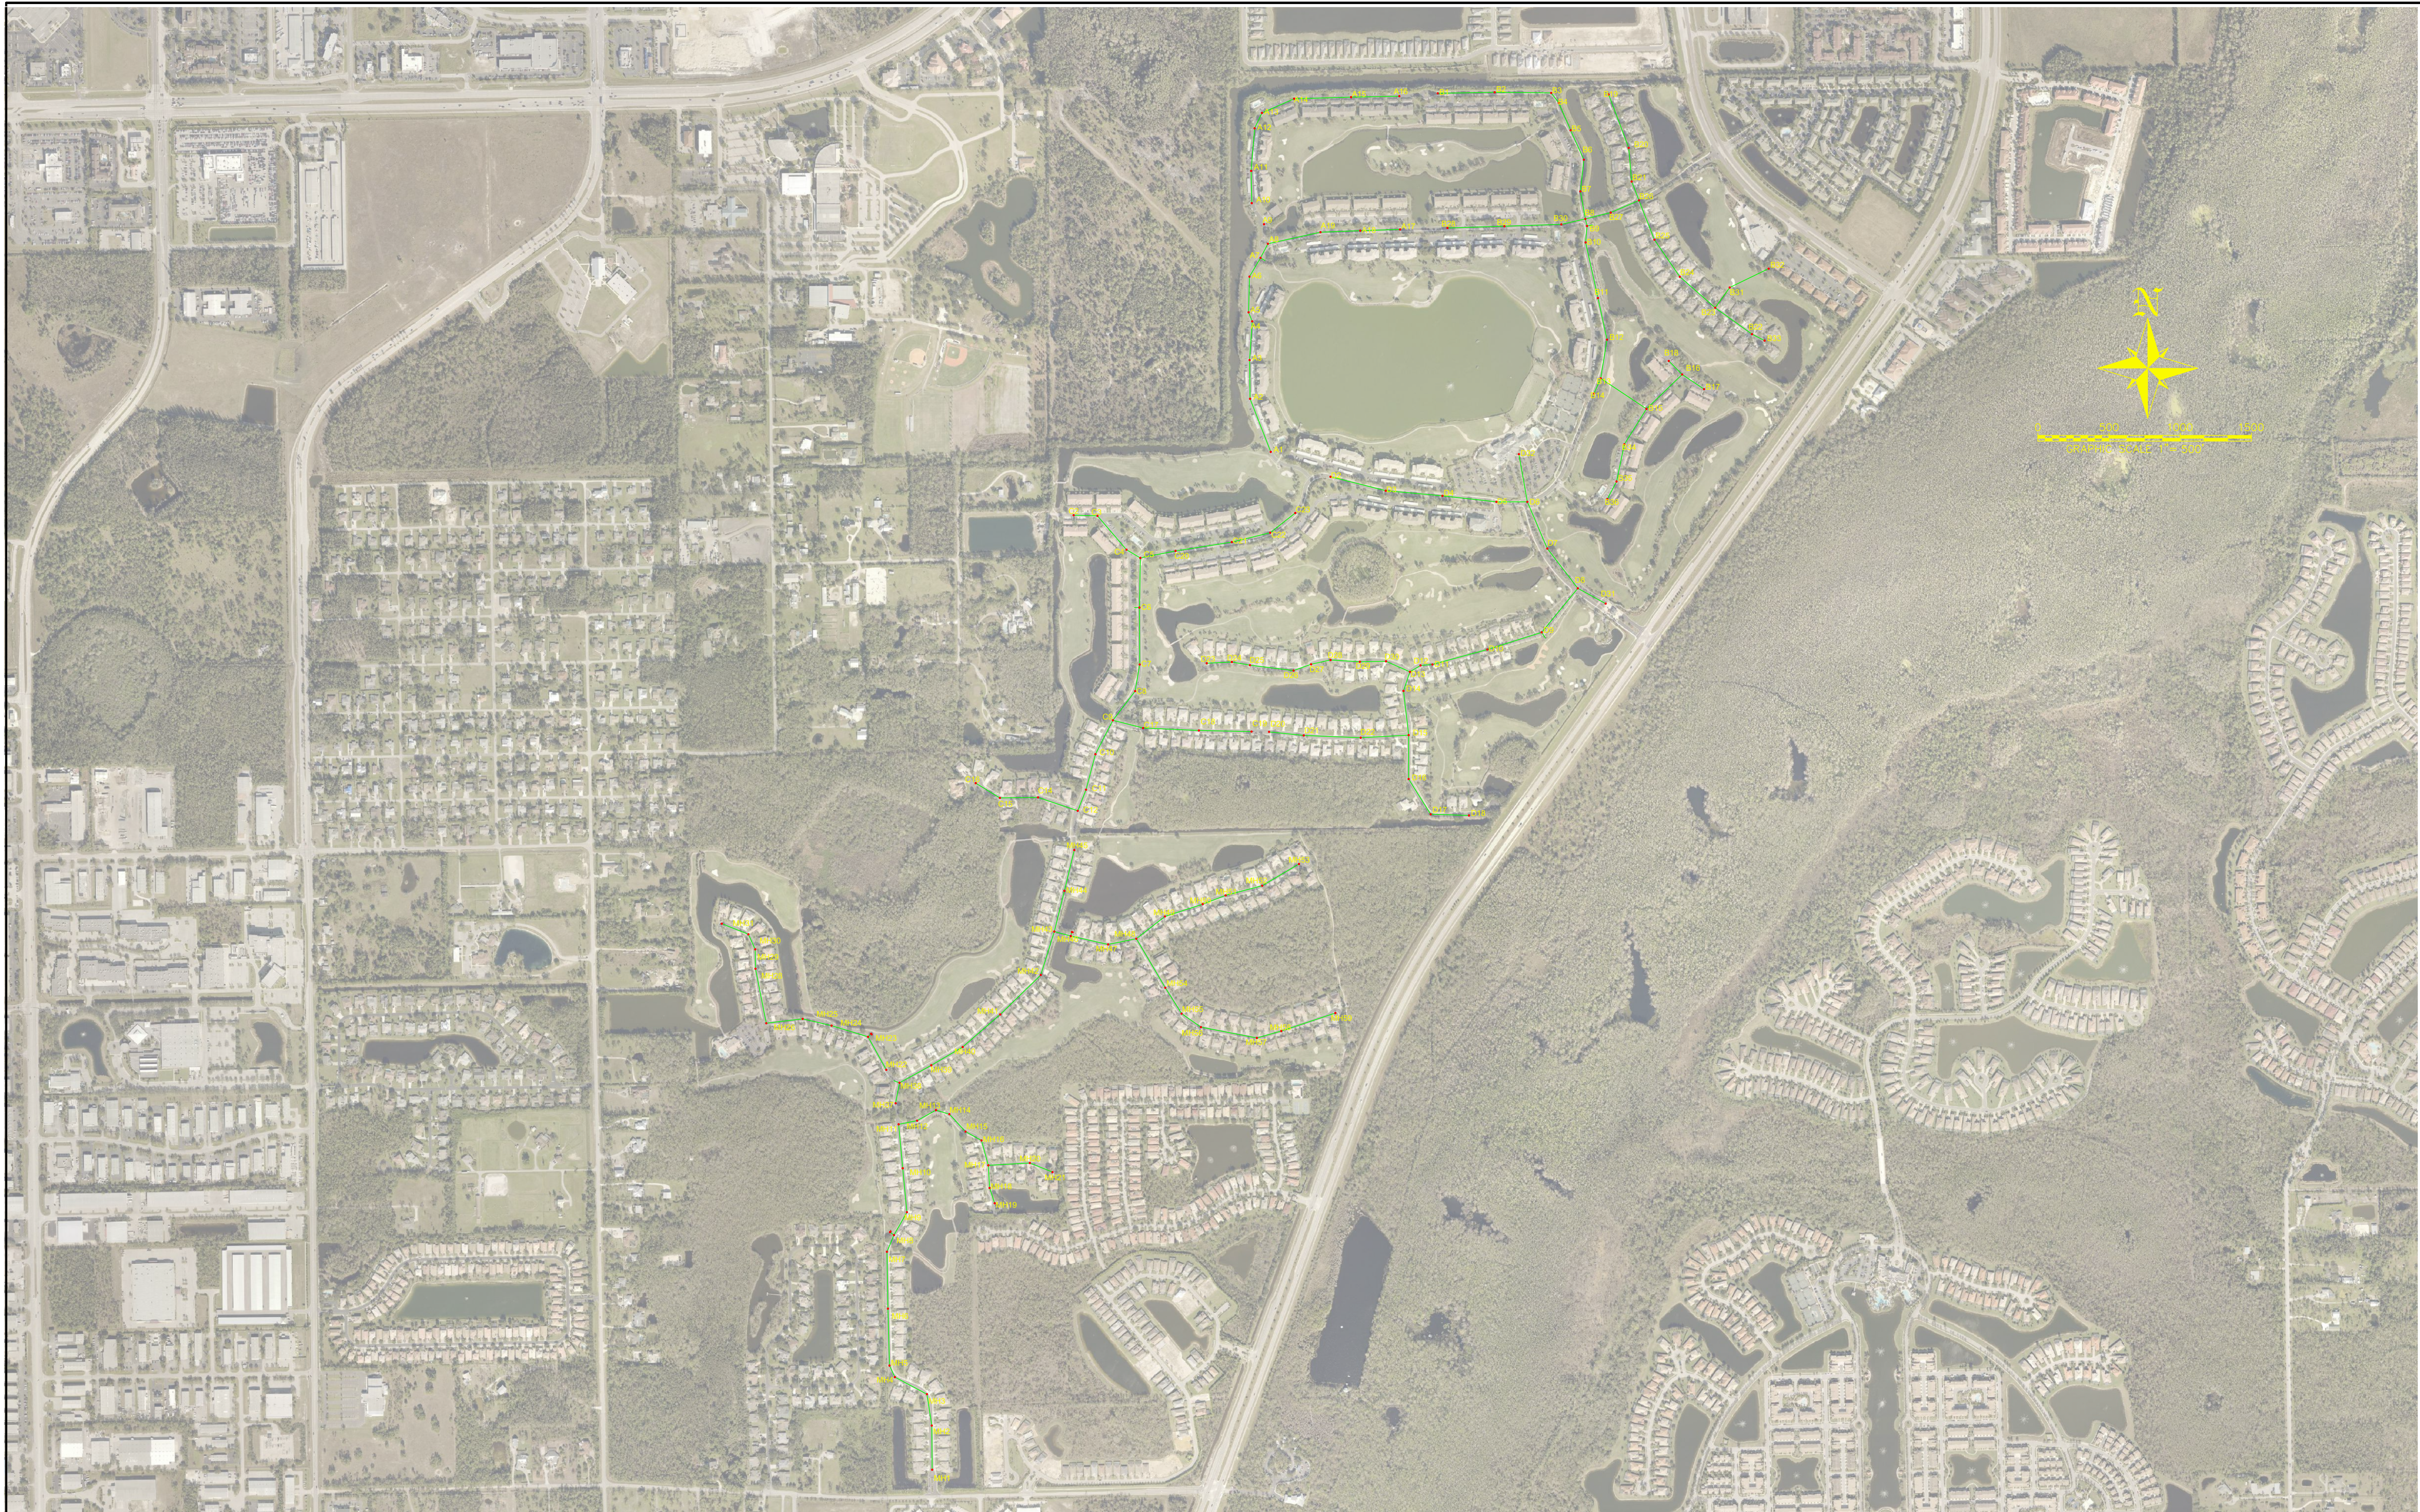
The visual inspection noted locations of manhole cover depths, level of severity and recommended height increase. The severity rankings used were;

- High Priority – Depth Greater than 1 Inch – Immediate Repair
- Medium Priority – Depth at .75 Inches – Future Repair
- Low Priority – Depth at .50 Inches – Potential Future Repair

After completing the inspection, we found that there are 31 manhole covers with a depth of 1 inch or greater, 37 manhole covers with a depth of .75 inches and 32 manhole covers with a depth of .5 inches. There were 9 manhole covers on the list that we could not locate which we believe may have been buried when the roads were micro-surfaced. The following report identifies these locations.
